Manhole Inspection Summary

Manhole # S15MM_005MH

Location Address: **2136 BRADDISH AVE**

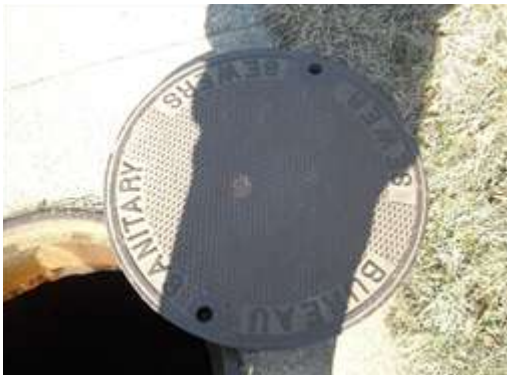
Defect 1

Frame Offset: **1** (in.) Condition: ☒ Sound ☐ Cracked ☐ Leaks

frame offset

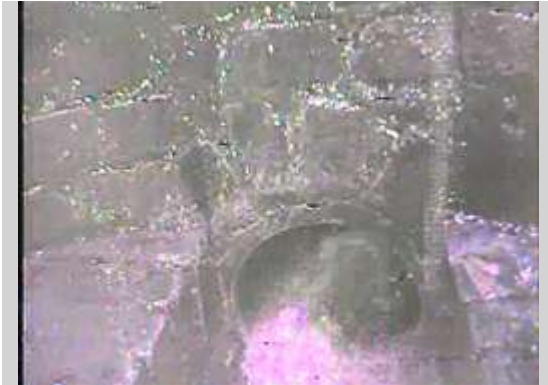
12 O'Clock Outflow

8 in. Circular Gravity Sewer
Pipe Out @ 12 O'Clock

Pipe Height: **8.4** (in.) Rod and Bar (Angled)
Pipe Material: **Clay** ☐ Pipe Lined
Invert Depth: **9.80** (ft.) Flow Characteristics: **Fast**
Deposits: ☒ None ☐ Mud ☐ Sludge ☐ Debris ☐ Grease
Silt Depth: (in.) Deposits Extent:
Infiltration: **None** Pipe Seal Cond: **Sound**

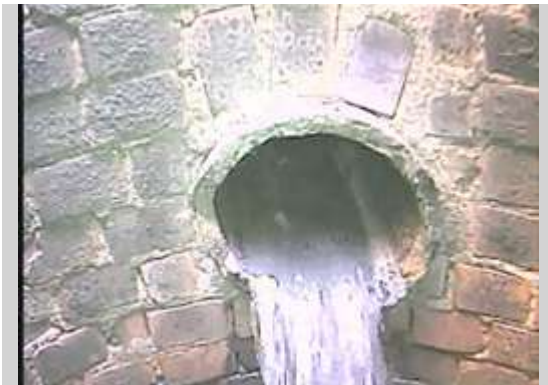
6 O'Clock Inflow

10 in. Circular Gravity Sewer
Pipe In @ 6 O'Clock

Pipe Height: **9.6** (in.) Rod and Bar (Angled)
Pipe Material: **Clay** ☐ Pipe Lined
Invert Depth: **4.47** (ft.) Flow Characteristics: **Fast**
Deposits: ☒ None ☐ Mud ☐ Sludge ☐ Debris ☐ Grease
Silt Depth: (in.) Deposits Extent:
Infiltration: **None** Pipe Seal Cond: **Sound**

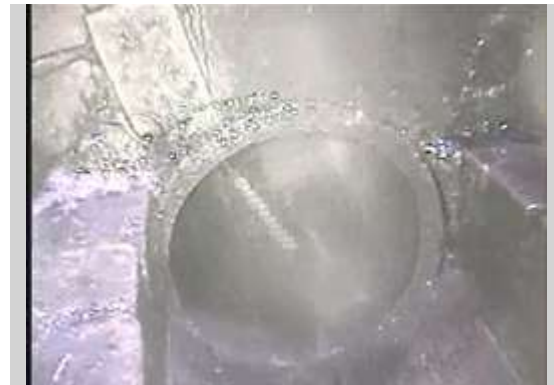
Drop In @ 6 O'Clock

Drop: **Outside** Rod and Bar
Angled: **Yes** Reading: **8.25** (ft.)
Inv Depth: **9.25** (ft.)
Drop Condition: **Open**
